CULTURAL LANDSCAPE REPORT WOLF TRAP NATIONAL PARK FOR THE PERFORMING ARTS

May 2021

Resource Stewardship and Science
Division of Cultural Resources, Region 1 - National Capital Area

Quinn Evans Architects
Washington, DC
Madison, WI

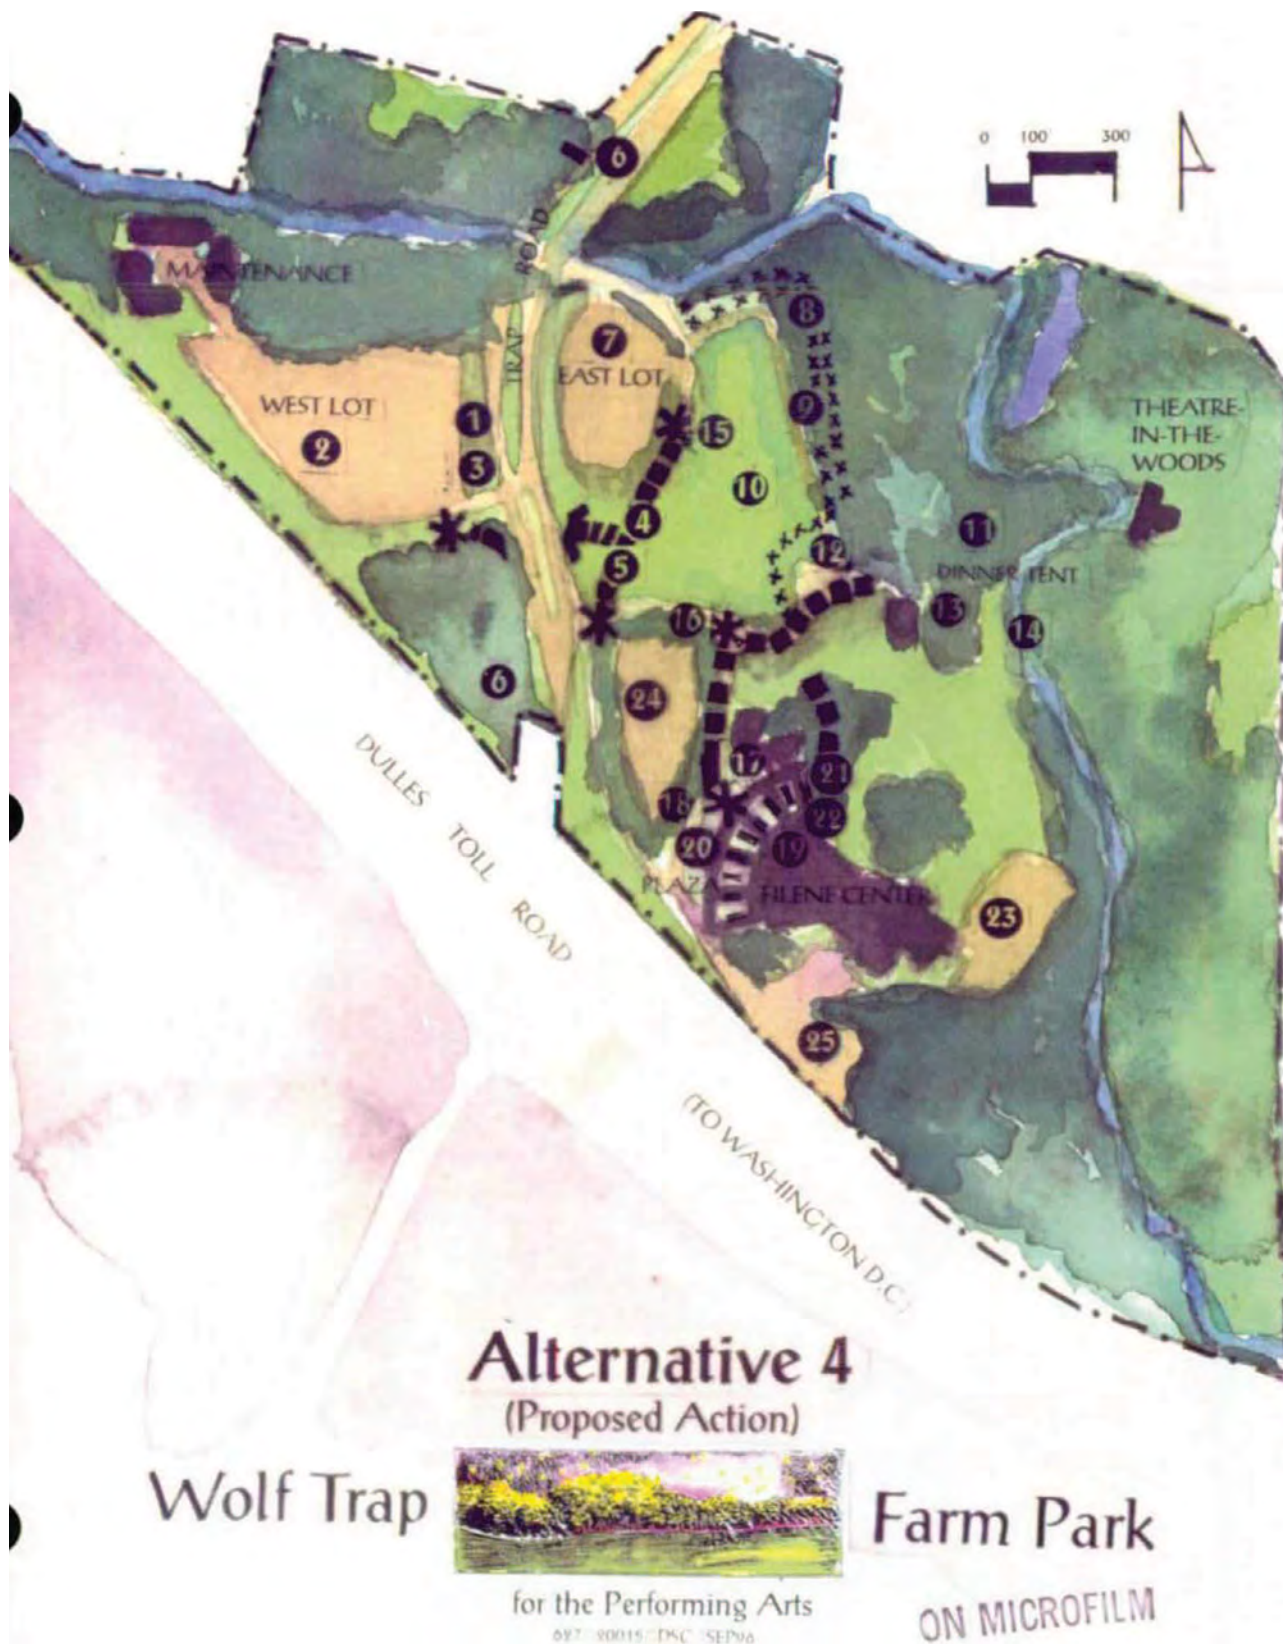
Figure 2-54. 1997 GMP Preferred Alternative drawing (National Park Service).

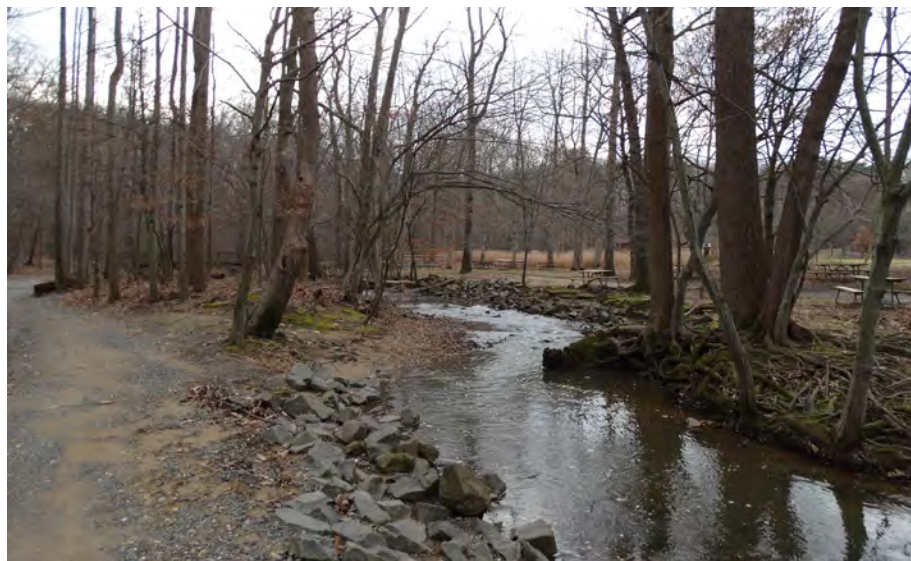
Figure 3-2. Armored portion of Wolftrap Creek (QE, 2020).

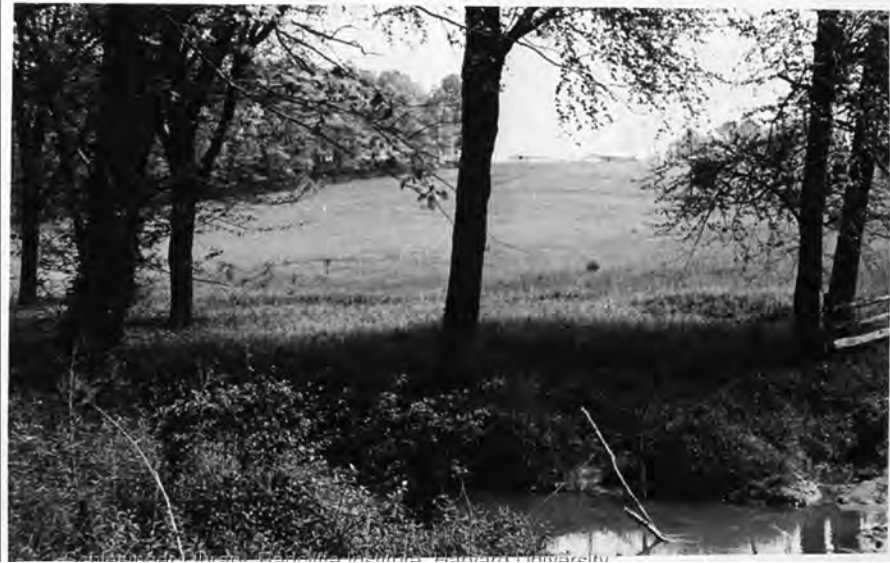
View D. View of Farm Core from Wolftrap Creek. Conditions related to both Wolf Trap Farm (1930-1965) and Wolf Trap Farm Park (1966-1984) are presented in the view from the East Meadow toward the ridge. In the northern portion of the meadow (right) is an expanse of mown turf and a glimpse of the Farm Core buildings. This view is primarily related to Wolf Trap Farm. In the meadow's southern portion, the Filene Center is partially visible from Wolftrap Creek, as it would have been during the Wolf Trap Farm Park period. Overall, the view is retained from the period of significance. The Ovations restaurant and deck are modern additions that slightly impact the scene.

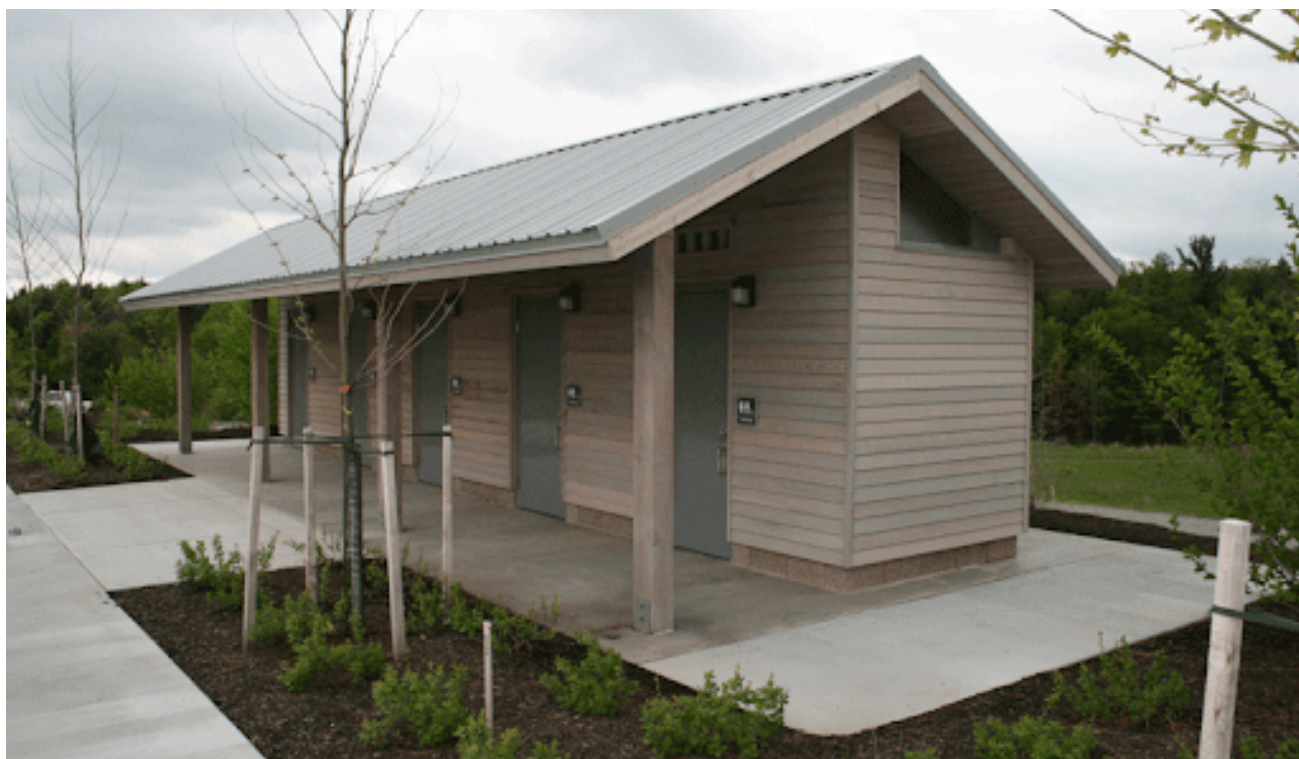
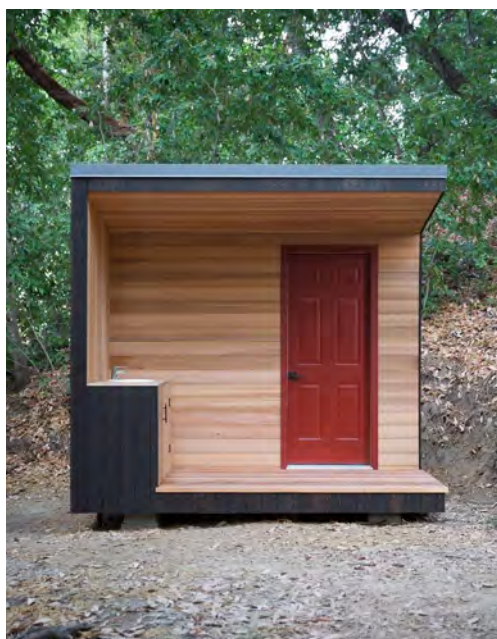
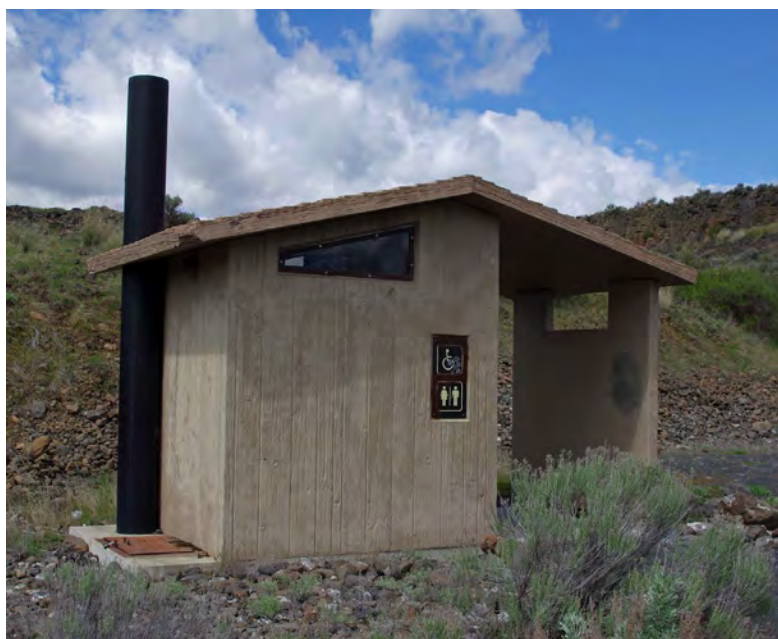
Figure 6-39. Proposed vault toilet precedent images showing compatible styles and materials. (RomTec, Dwell, and US Backroads).
